Bio-Bead pollution on our beaches

**A Cornish Plastic Pollution Coalition report
Second edition, July 2018**

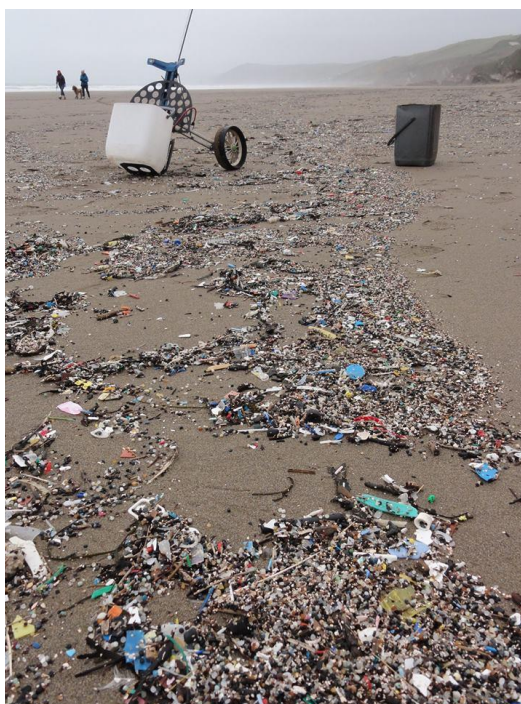
**A common scene in winter and spring. A tideline of mixed microplastics stretching for hundreds of metres at Tregantle, Whitsand Bay, April 2017
Picture: Rob Arnold**

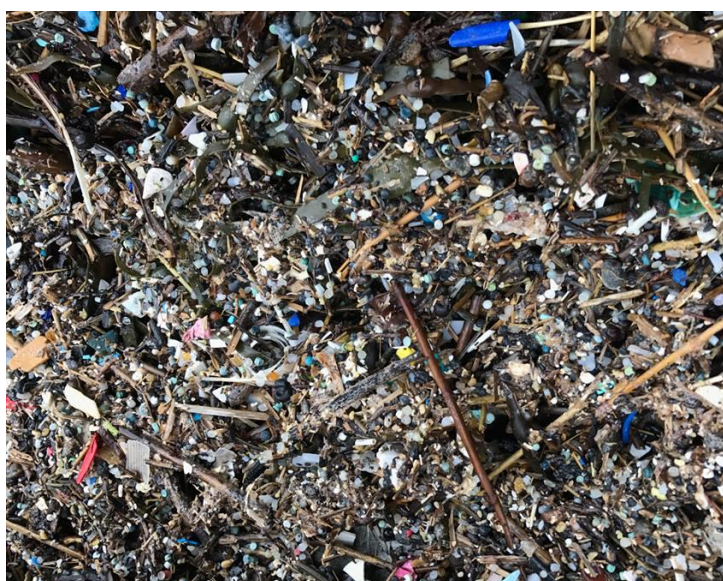
**Detail of typical mix of organic material, microplastic pieces, nurdles and Bio-Beads – extremely hard to remove and to sort. Hayle, March 2017
Picture: Tracey Williams**

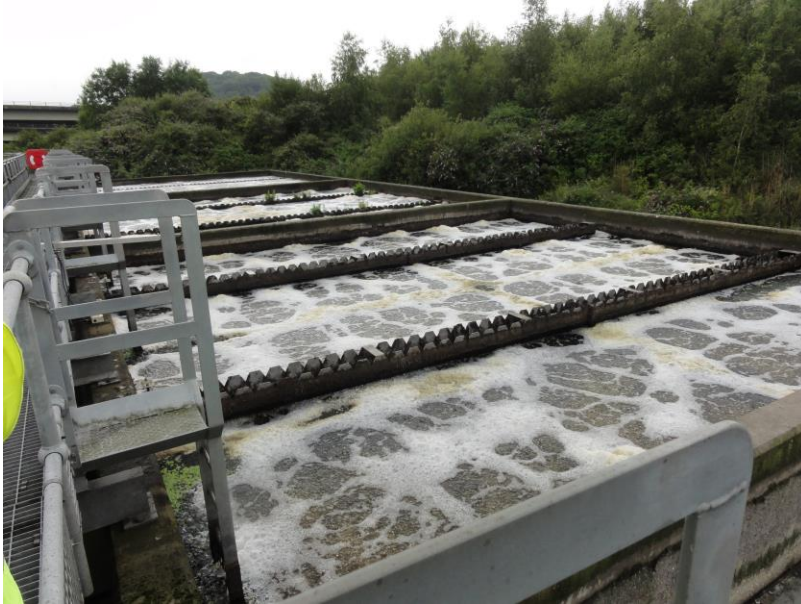
View of reactors in operation, from above (SWW Plympton plant, June 2017). Water bubbles up through the Bio-Bead bed, then through the steel mesh above it, before running down the raised channels, visible above the tanks, to the outflow.

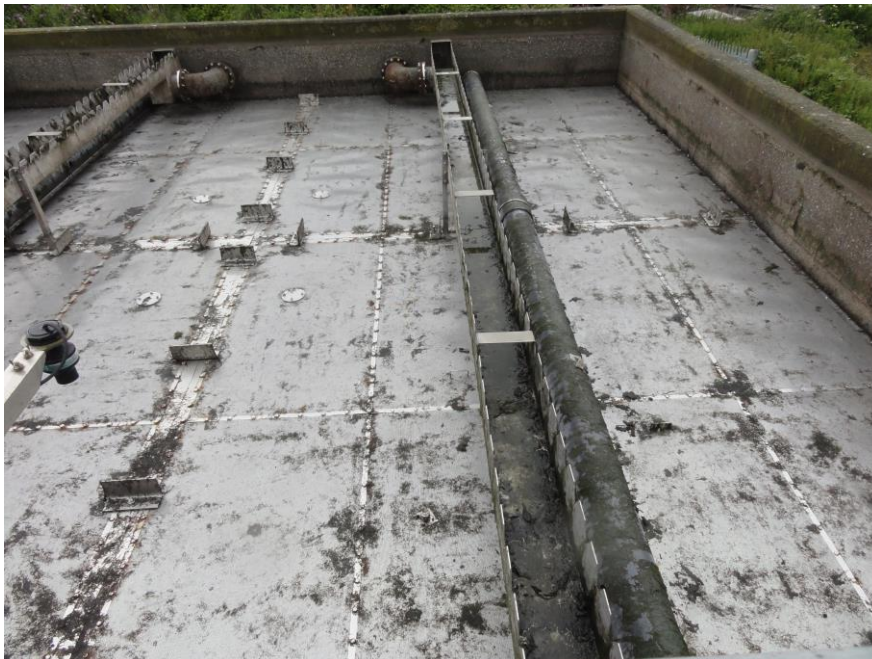
Image of an empty tank (SWW Plympton plant, June 2017), showing the position of the steel mesh screen in the reactors.

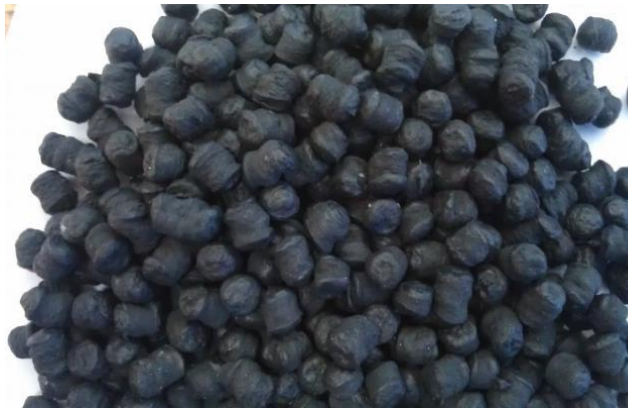
Left: Image of Bio-Beads taken from the FLI Water website

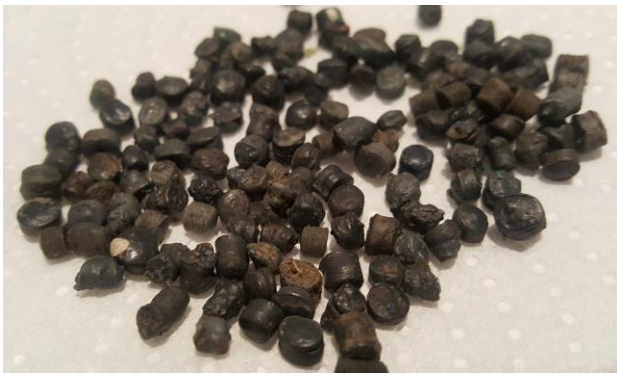
Below left: Black Bio-Beads collected from Plympton site in January 2017 (picture: Claire Wallerstein)

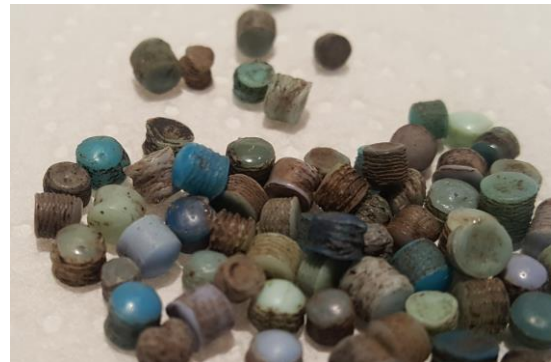
Below right: Coloured Bio-Beads collected from Plympton site in January 2017 (picture: Claire Wallerstein)

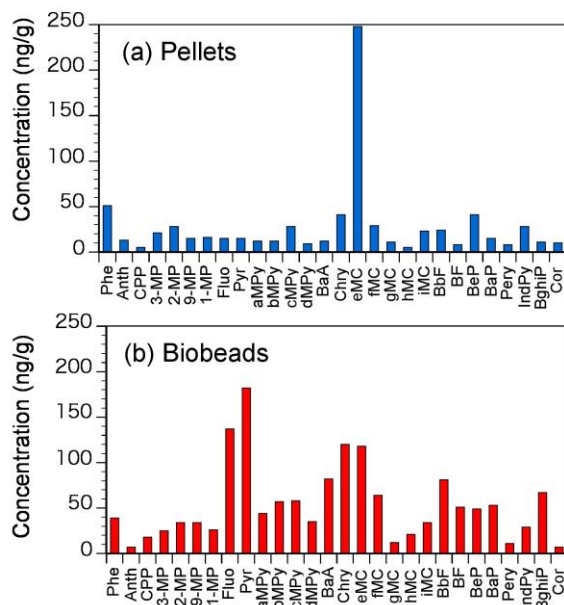
Left: Charts showing the very different chemical signatures of Bio-Beads and nurdles from Tregantle beach, SE Cornwall, in terms of the levels of adsorbed polycyclic aromatic hydrocarbons.

PAHs derive from burning hydrocarbons, so the most logical explanation is that the Bio-Beads (unlike the nurdles) would have been exposed to vehicle exhaust emissions in roadwater runoff while in the wastewater plants.

The results showed that while the levels of DDT, PCBs, etc. were similar on both types of pellets, the Bio-Beads showed levels of polycyclic aromatic hydrocarbons (PAHs) three to four times higher than those on the nurdles – confirming that the two types of pellets, although made of the same kind of plastic, had entered the marine environment from very different sources.

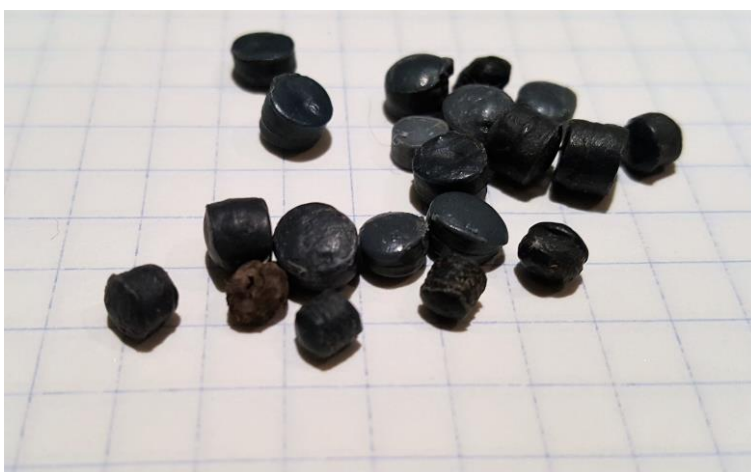
Pellets found by kayaker Mary James along a small area of riverbank on the Truro River at Malpas on February 18, 2018

The Newham plant was decommissioned following the spill. However, Mary James, a kayaker who regularly cleans up plastic waste along the length of the Truro river, finds Bio-Beads still deposited on the banks in large numbers if she digs down deep enough under the leaf litter and grass – over eight years after the spill.

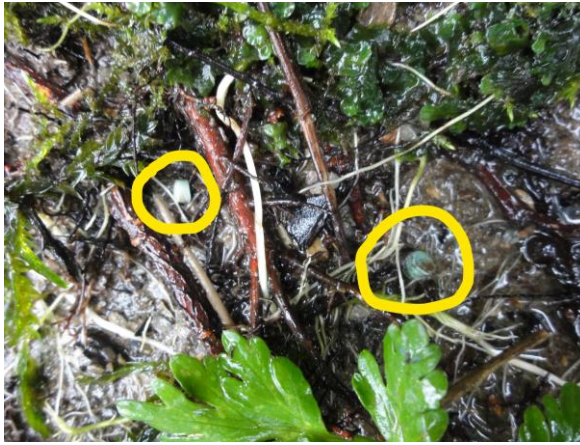
Above left: Bio-Beads in situ on the banks of non-tidal part of the East Looe river, March 2017

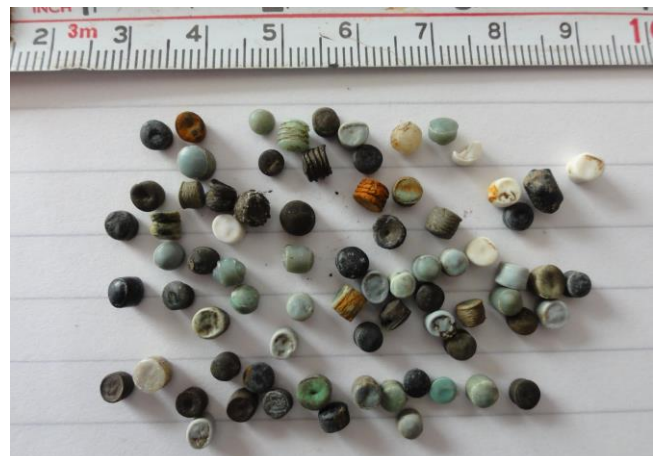
Above right: pellets caught in a small sieve a short distance downstream of the wastewater plant outfall over a 10-day period in July 2017. All these pellets measure more than 3mm. However, rust deposits on some of them may indicate possible deterioration in the steelwork of the reactor.

This shows that Bio-Beads can escape from plants and are certainly doing so at Liskeard. However, RPBC was only able to carry out short surveys and the scale and pattern of these losses are not clear. Although some of the beads caught here looked quite worn, none measured less than 3mm so it seems unlikely they are escaping through the holes in the retaining mesh screen. However, rust deposits on some of them could possibly indicate deterioration in the steelwork of the reactor.

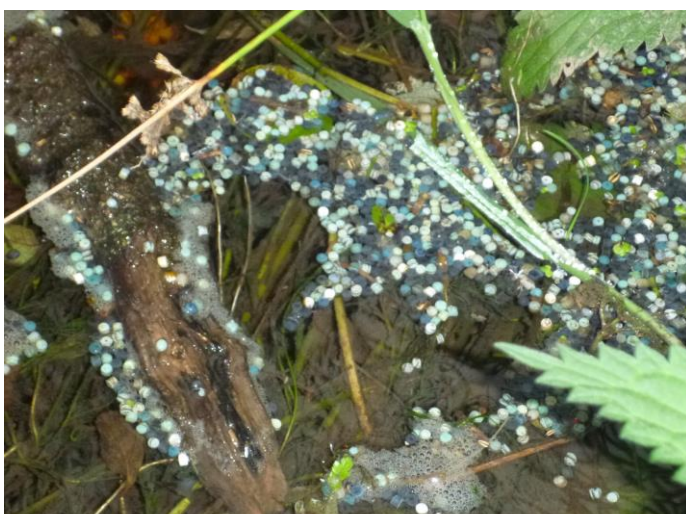
Bio-Beads seem to have been lost from the Liskeard plant over a long period of time. The image to the left was taken in 2014 by a Cornwall Wildlife Trust ecologist undertaking surveying at Higher Coombe, just a short way downstream of the Liskeard plant outfall. She took this photo as she was shocked to find the river with so many beads in it, though she had no idea at the time what they were.

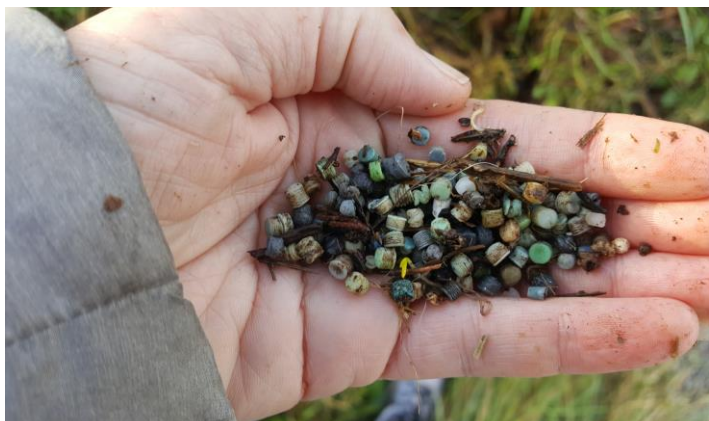
Above: 249 Bio-Beads found in a 50cm² area of riverbank downstream from the Plympton plant at the Blagdon's Meadow County Wildlife Site. Some beads were lying on the surface of vegetation, others were buried right down into the sediment, apparently having been there for a long time.

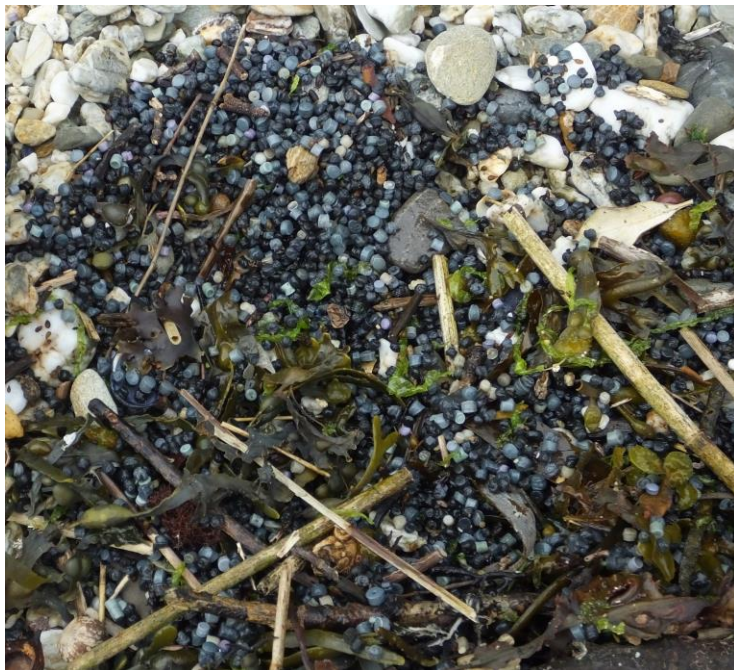
Bio-Beads and nurdles in situ at Colona beach in St Austell Bay (left) and a handful collected from a whole tideline of similar beads at Watergate Bay (below right), both in September 2015, after Cornwall had experienced double the normal amount of rainfall in August (Met Office). Pictures: Rob Wells and Bex Allen

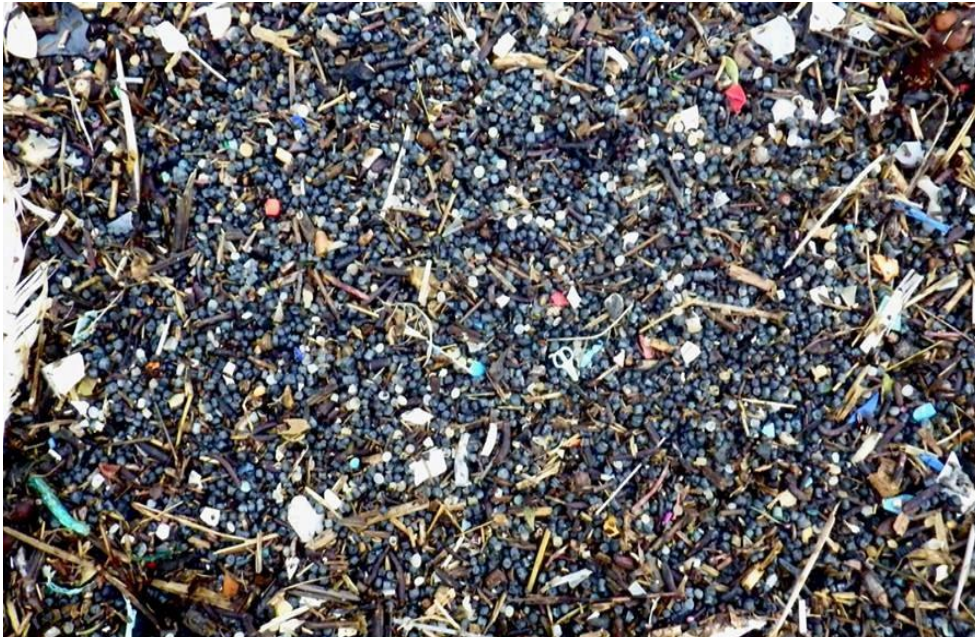
Left: Bio-Beads found by Andy Dinsdale at Camber Sands, East Sussex following torrential rains in February 2017

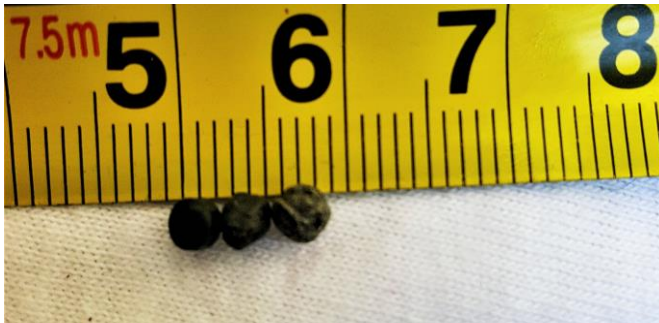
Many beached Bio-Beads are very small (barely 3mm) – but were they worn down before or after being lost?

We have certainly found that some of the Bio-Beads on our beaches seem very small, barely measuring 3mm across – but is this the result of wear after a long time in the sea, or did they become worn down to this size prior to being lost from plants?

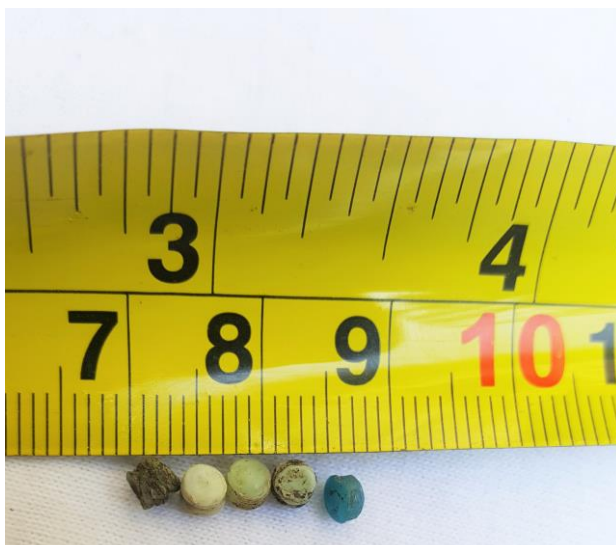
Some pellets collected from the South West Water plant at Plympton in January 2017 seem to measure only just 3mm – the same width as the holes in the screen over the top of the BAFF reactors. The fact that they still have their original ridging suggests that abrasion is not the cause. Picture: Claire Wallerstein

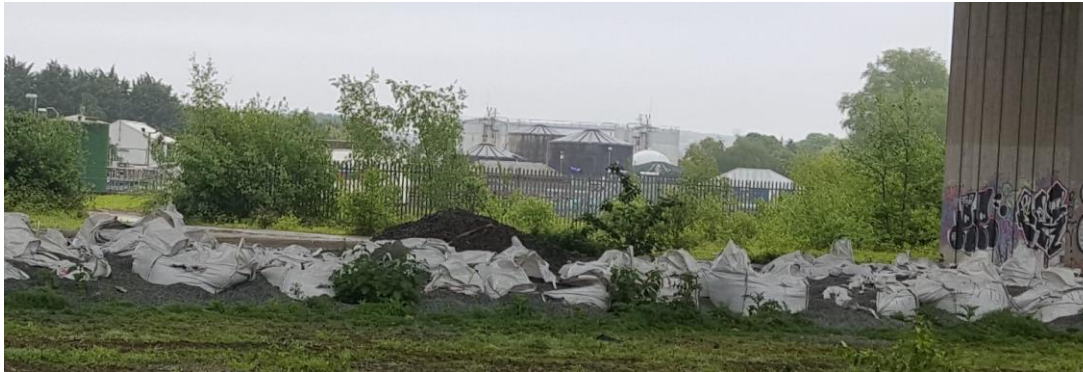
Bio-Beads spilling out of open dumpy sacks in the SWW storage area near the Plympton plant.

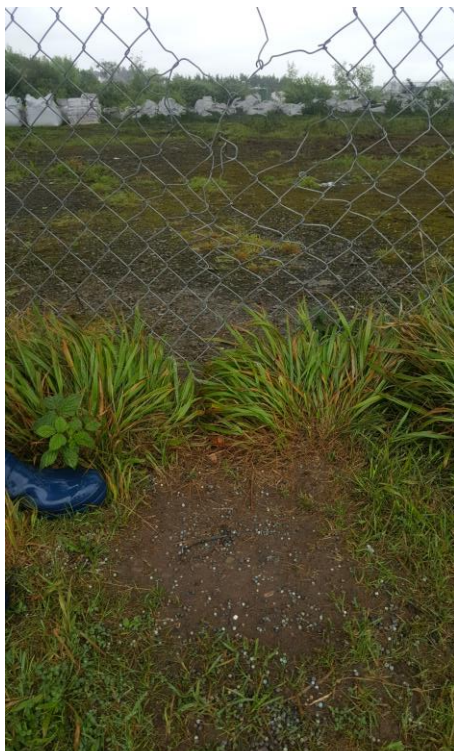
Left: A hole through the fence to the SWW storage area along the public footpath adjoining the Plympton plant site, dumpy sacks visible in the background, Bio-Beads in the foreground , 17 May 2017 (Claire Wallerstein)

Given the significant amounts of graffiti on the pillars supporting the A38 dual carriageway above, it seems that the site must have been frequently entered by intruders. The location – alongside a public footpath and right by a river – also seemed to be a poor choice for storing a material of this kind.

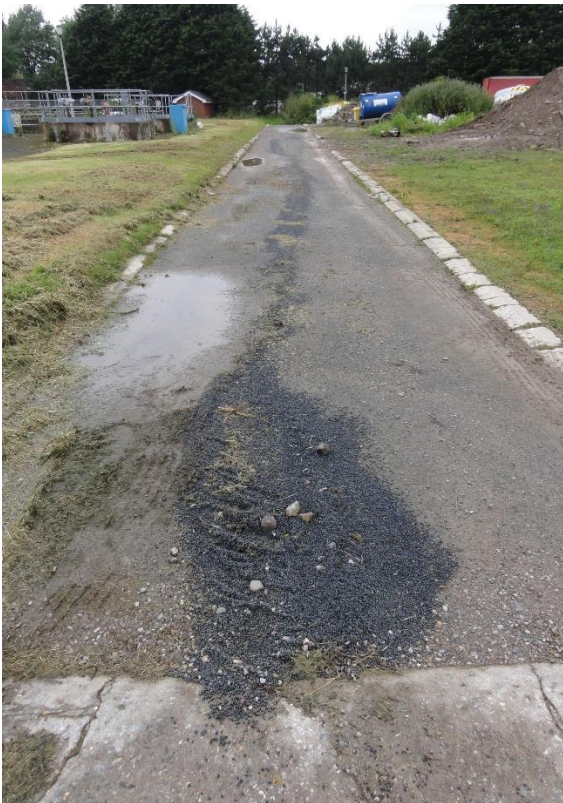
Trail of black Bio-Beads spilled along the length of a road within the Plympton site, following removal of the vandalised sacks of beads to a more secure location, June 2017

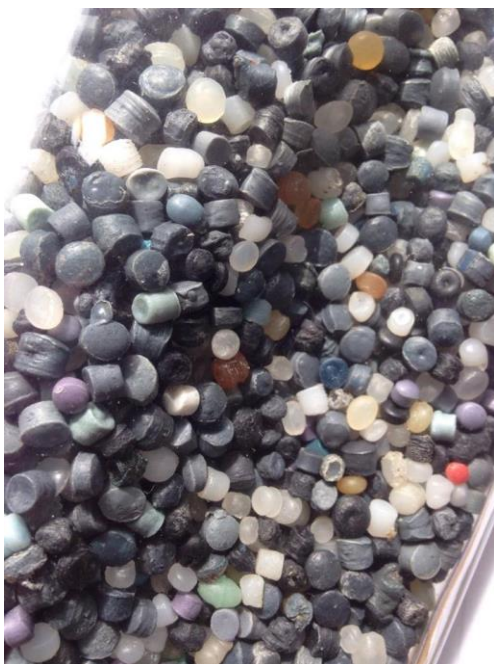
Some Bio-Beads among a collection of industrial pellets picked up on the Isles of Scilly. (Bio-Beads make up a minority of the pellets here and were collected from more than one beach over a period of time).

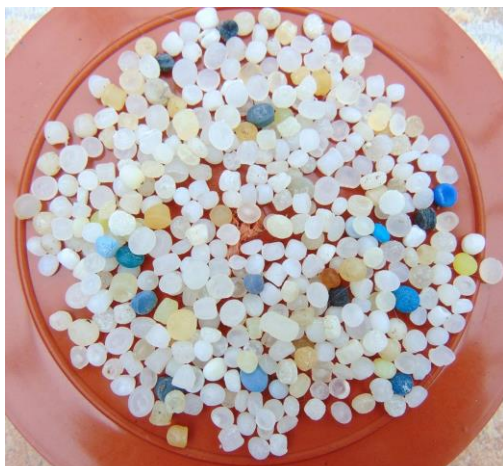
Typical pellets collected from St Finian's Bay, Co. Kerry, Ireland – just four or five possible Bio-Beads.

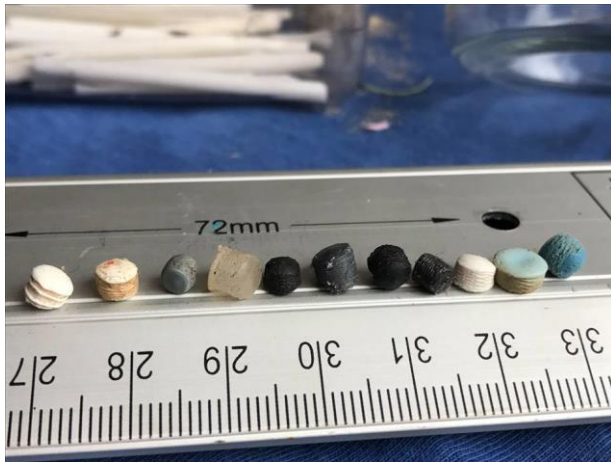
Distinctively-ridged Bio-Beads found between Le Porge and Contis in Aquitaine, SW France.

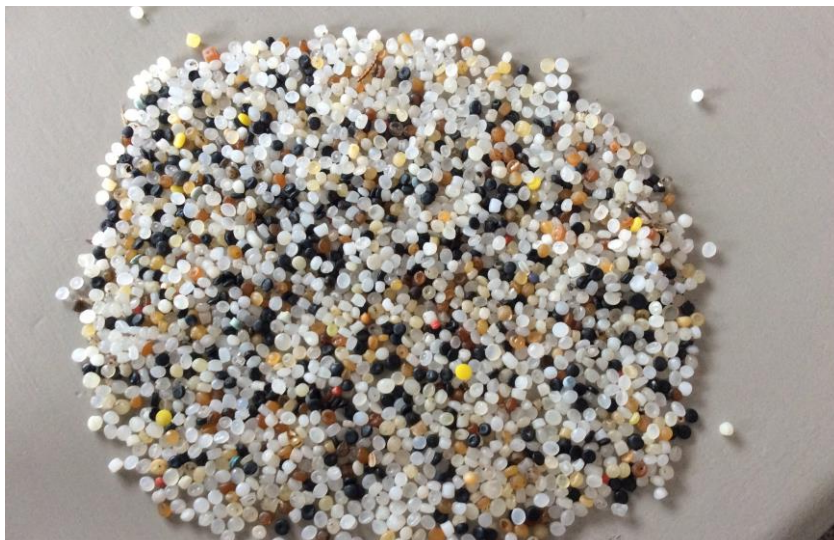
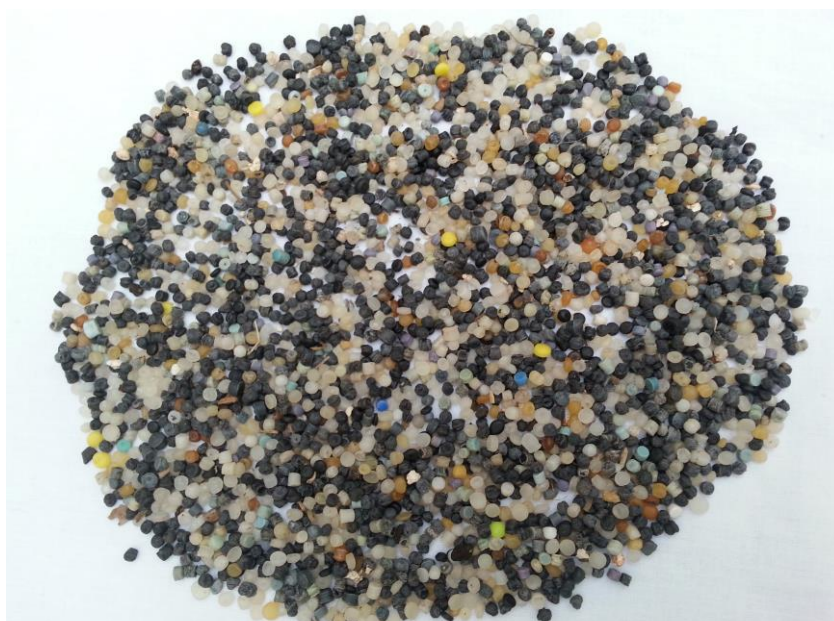
Sample of pellets collected near Le Conquet, Brittany (above) and a similar sample from Tregantle, Whitsand Bay (below). It is striking that the Brittany sample comprises predominantly white pre-production nurdles. The black pellets all seem to be lentil-shaped, smooth pre-production plastic nurdles. Bio-Beads are not apparently present in this. In the Tregantle sample, a large number are black Bio-Beads.

NB: The bright yellow pellets in both samples are believed to have come from a container lost from the MSC Napoli, which started to break up between England and France due south of the Lizard in January 2007, while on route from Belgium to Portugal.

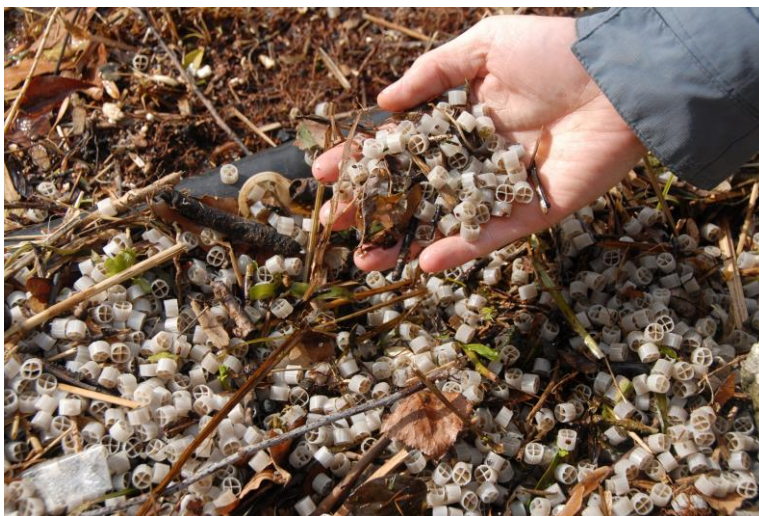
Another type of biomedica, this one wheel shaped, commonly used in wastewater treatment in the UK as well as elsewhere. This image is from a spill in Corbeil Essone (near Paris) in February 2010 when a municipal wastewater treatment plant lost 800m3 of biomedica into the river Seine.

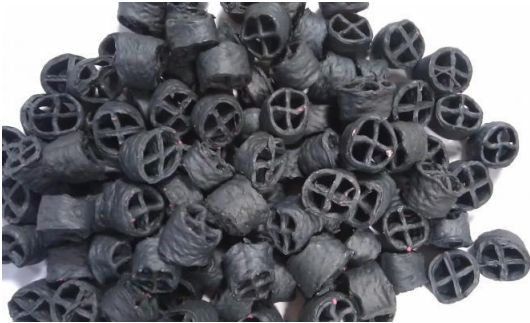
B-Max media (picture from FLI Water website www.fliwater.com)

Northumbrian Water does not use Bio-Beads. However, it does use another type of plastic media (B-Max) supplied by FLI Water at 'certain sites' (locations and number of sites not yet confirmed), and has experienced losses of media in incidents at three of these plants.

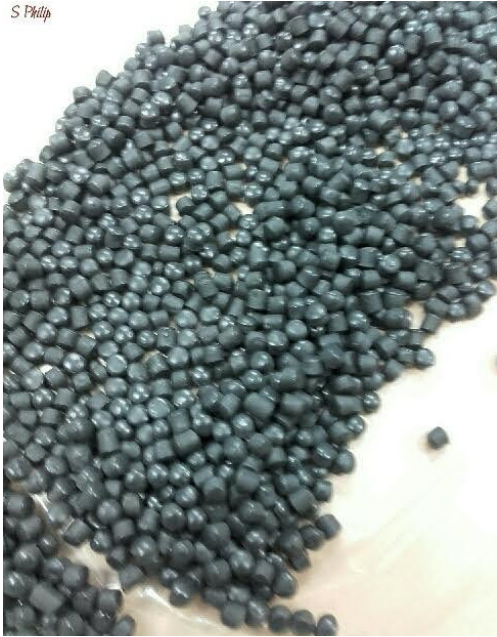
Left: Picture of Bio-Beads used at Southern Water plants

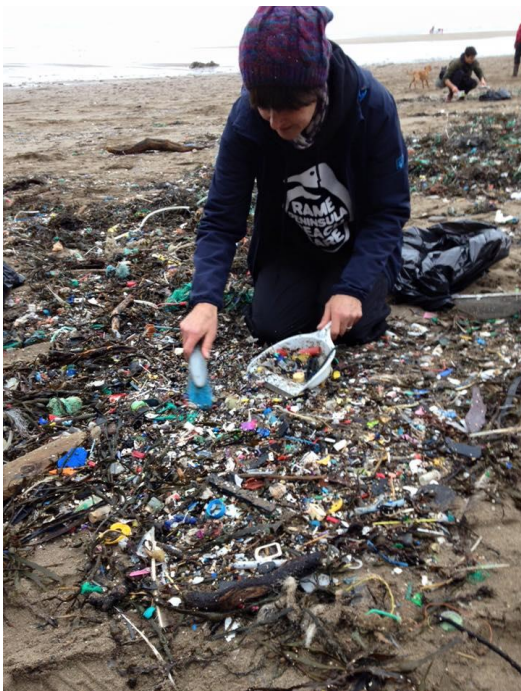
Trying to sweep up the tangle of microplastics – often trodden into the sand and buried inches deep – with dustpans and brushes, January 2016 and March 2017.

Although the machine has its limitations (it needs to be transported right down to the beach by vehicle, requires a fresh water source and plenty of volunteer help to sweep the beach), it has been extremely effective at Tregantle.

In just three sessions on the area of beach at the bottom of the slipway (approximately 100m wide), Rob removed approximately four million pellets (including over two million Bio-Beads) in March 2017 (counting methodology as described in section 7), with a further five to six million removed over the next year.

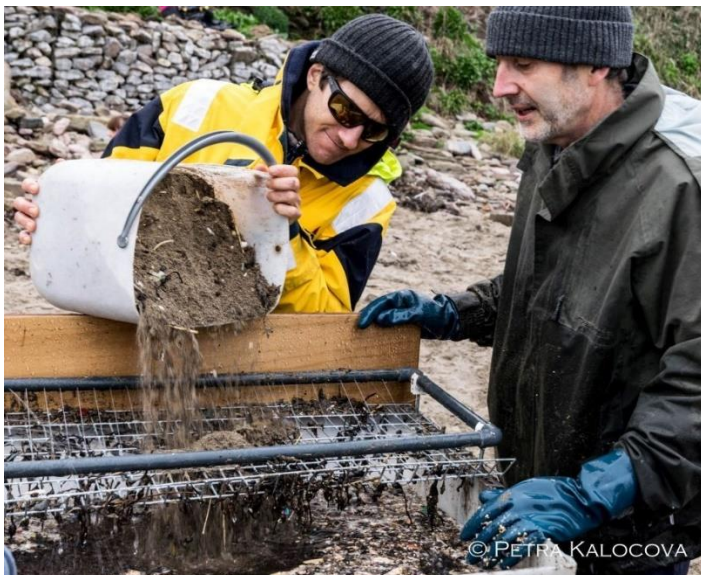
Using the machine to separate microplastics, including Bio-Beads, from the sand, March 2017

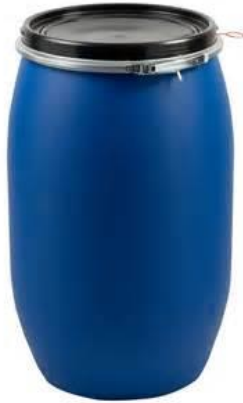
HDPE storage drum

We do not believe that the flexible dumpy sacks currently used are a safe way of storing an easily-lost material such as Bio-Beads, potentially over long periods of time, or of transporting the media around a site.

We believe that tough, closed, tamper-proof and continuously-reusable rigid HDPE drums would be a much better choice of storage container for biomedica.
